# Insurance Condition and Valuation Report

## Amy-Dee - XU897Q

<b>Client Name</b>	David Anthony
<b>MSA Client Reference</b>	Amy-Dee - XU897Q MSA/REC/24/07
<b>Survey Scope</b>	Condition and valuation inspection for insurance purposes
<b>Survey Location</b>	Cairns, Queensland
<b>Date of Survey</b>	18 <sup>th</sup> January 2024
<b>Prepared by AMSA Accredited Marine Surveyor</b>	Kieran Torti Surveyor ID: 4402-0228 6 Ph: 0458 369 128 E: kieran@maritimesurveyaustralia.com.au

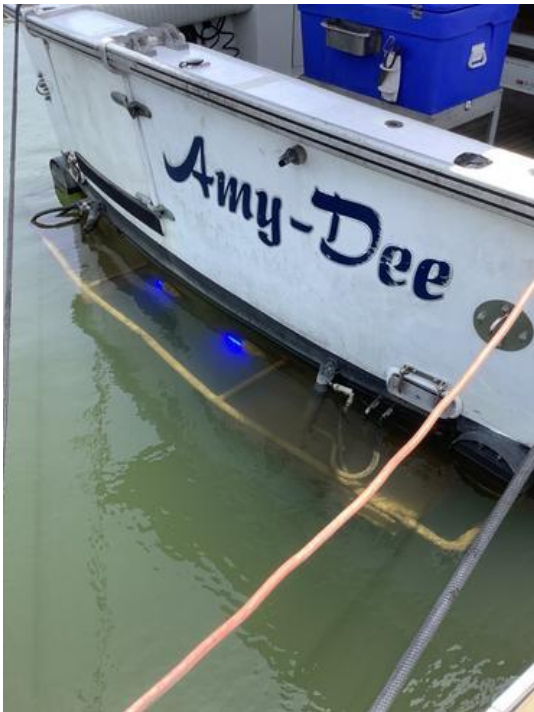
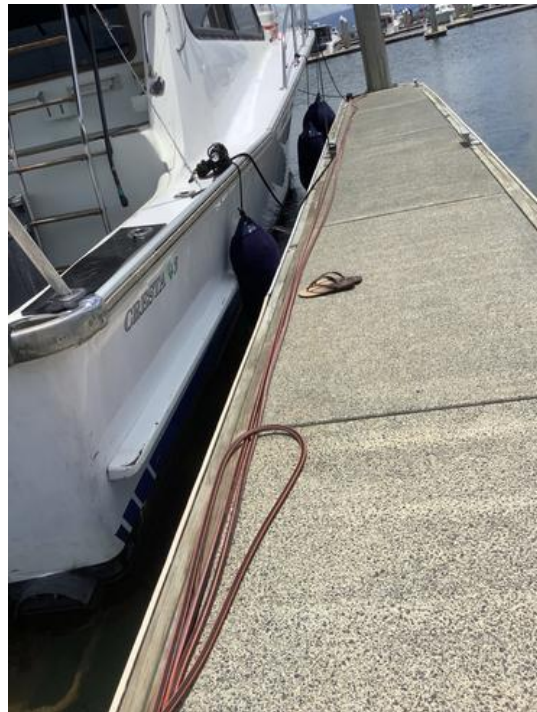
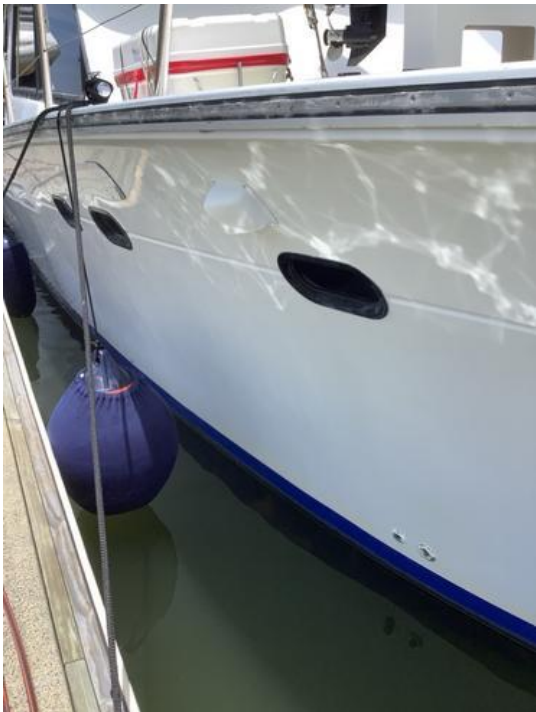
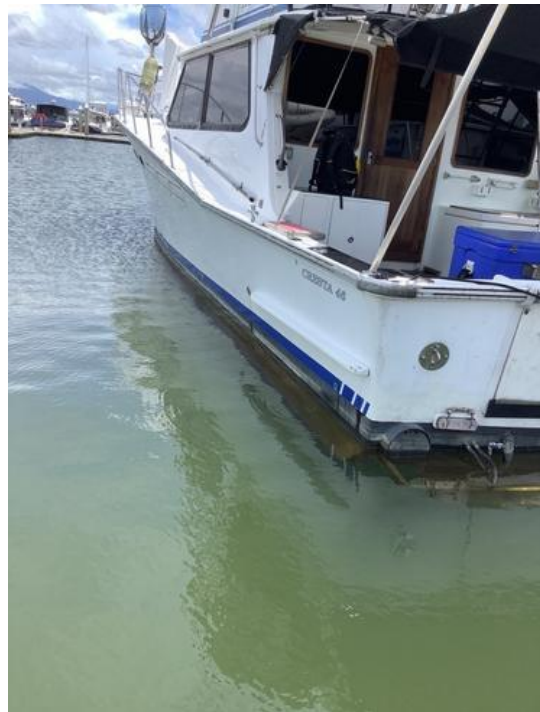
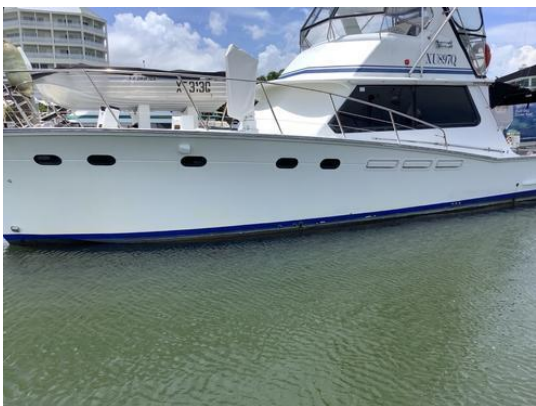
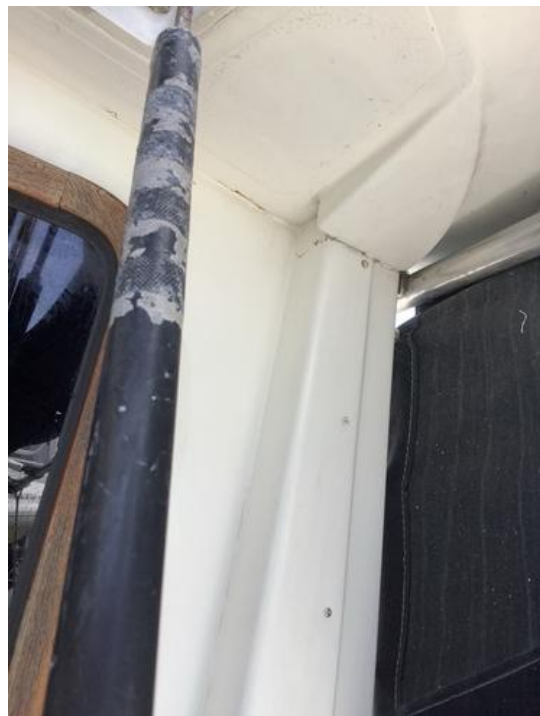
The condition of the whole was determined to be in satisfactory condition, slight scuff marks, and minor gelcoat deficiencies were identified.

Overall, there were no major deficiencies identified at the time of the survey.

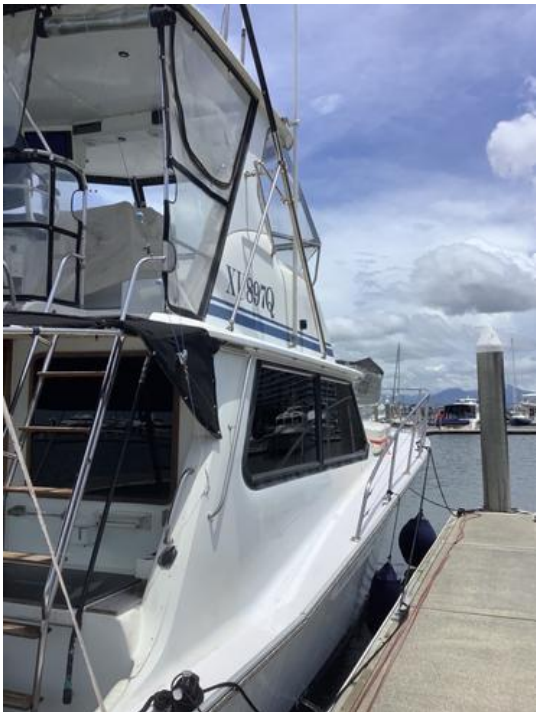
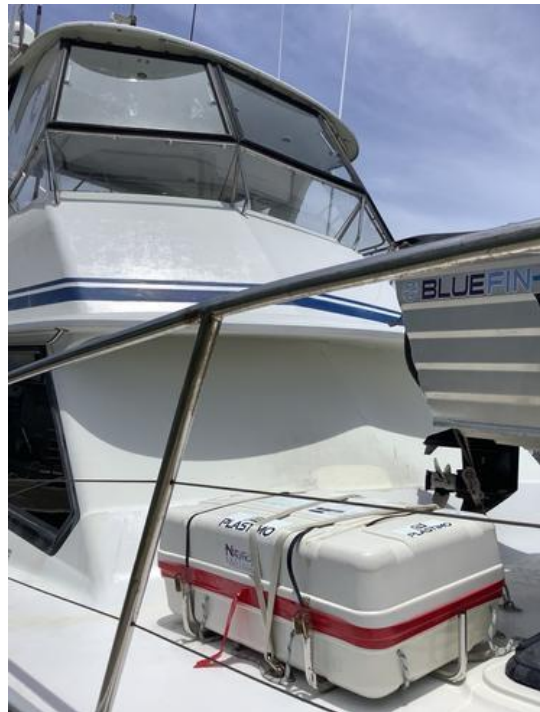
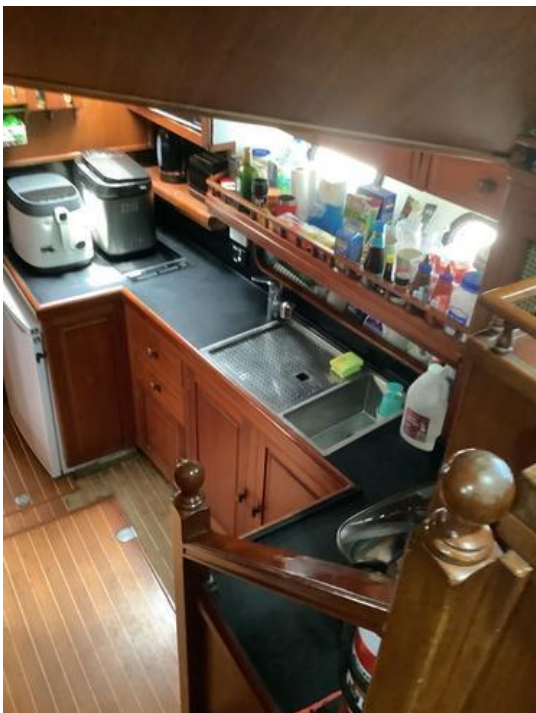
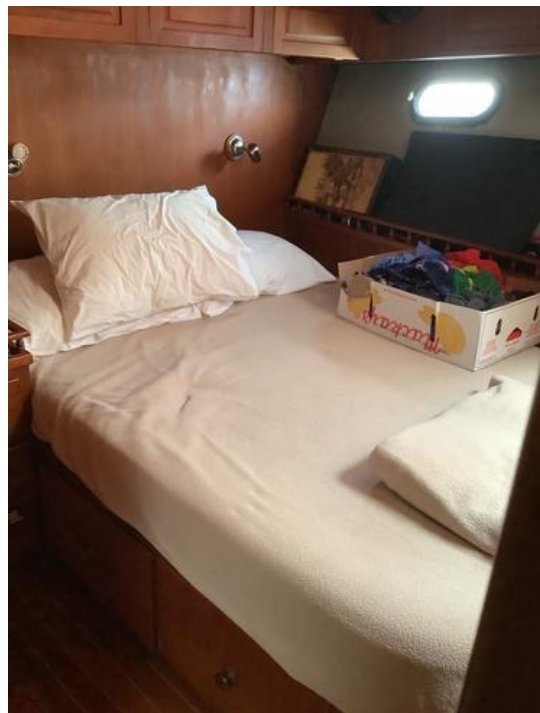
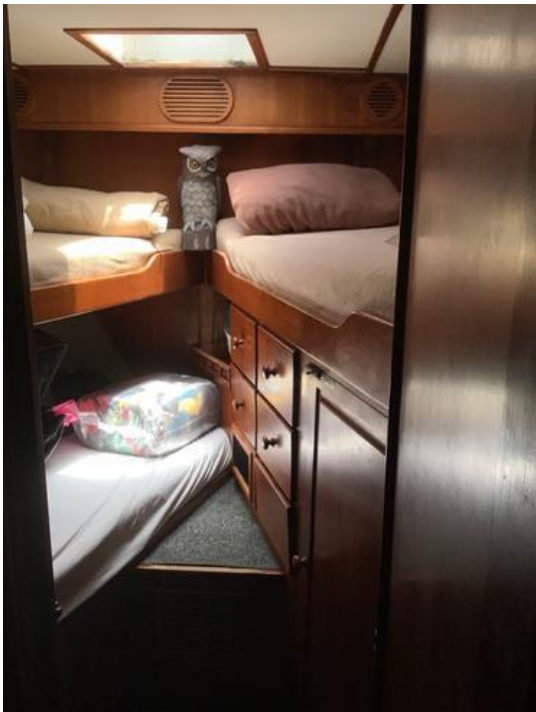
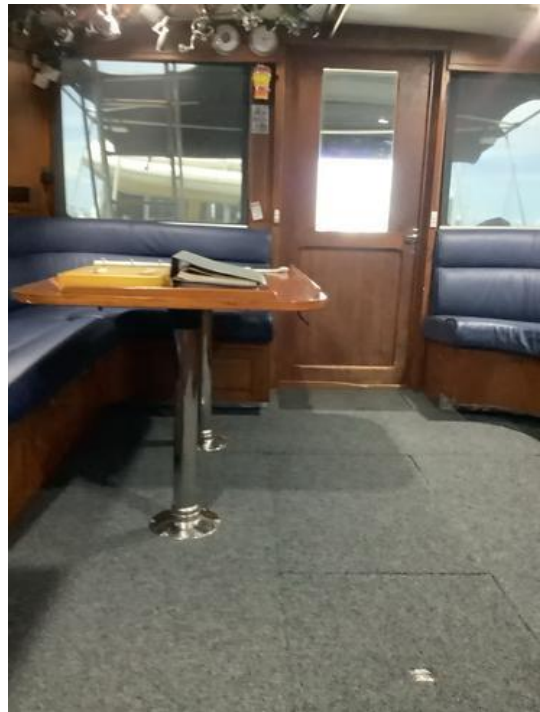
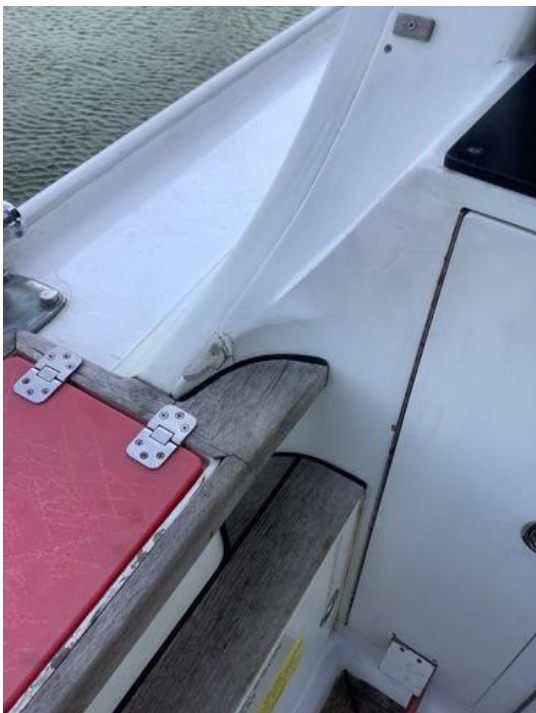
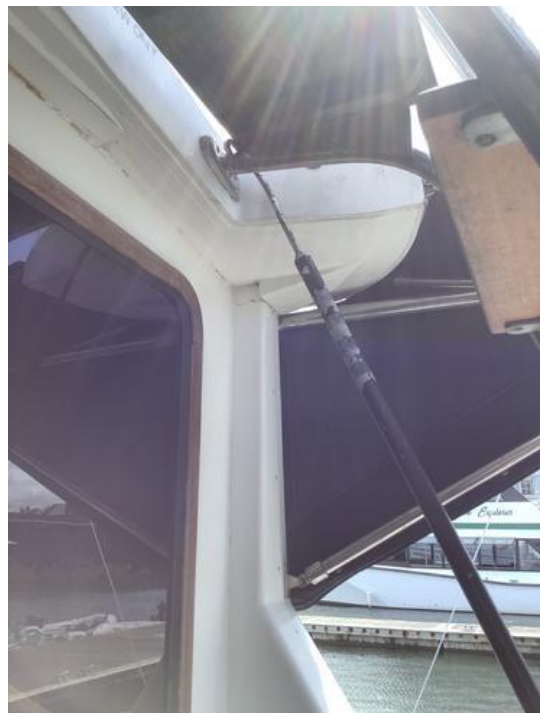
The superstructure was inspected and found to be in satisfactory condition.

Some areas on the port and starboard side below the windows was found to have UV damage and minor wear on the gelcoat.

The fly bridge superstructure was found to be in good condition. The Interface between the flybridge and main deck was satisfactory, some minor signs of UV damage.

The foredeck and side decks have recently been re-coated. System applied, unknown.

The accommodation areas were found to be clean and tidy with no signs of excessive wear or damage.

The main salon seats look to have been recently recovered and the carpet was in good condition.

The galley was in satisfactory condition, signs of wear and aging to be expected for a vessel of this era. The timber deck was worn and requires maintenance, this mostly for aesthetics and longevity, no safety risks were identified.

The cabins were inspected and found to be in good condition. No major defects were found.

The teak deck on the aft deck is showing signs of aging, no major defects were identified.

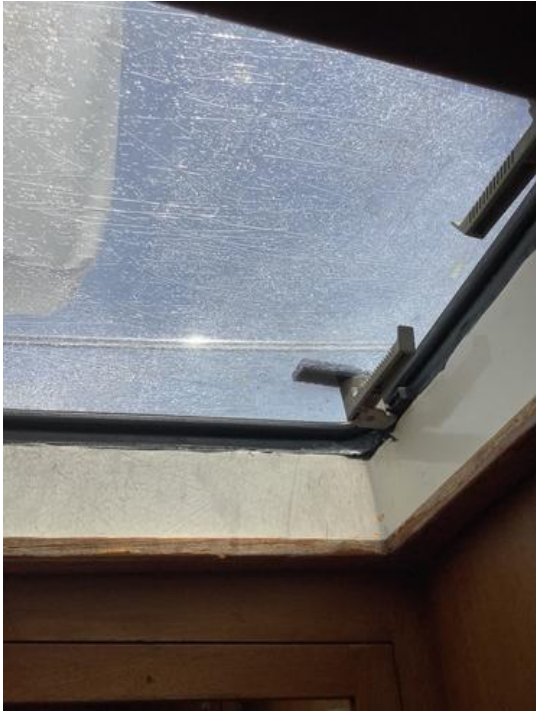
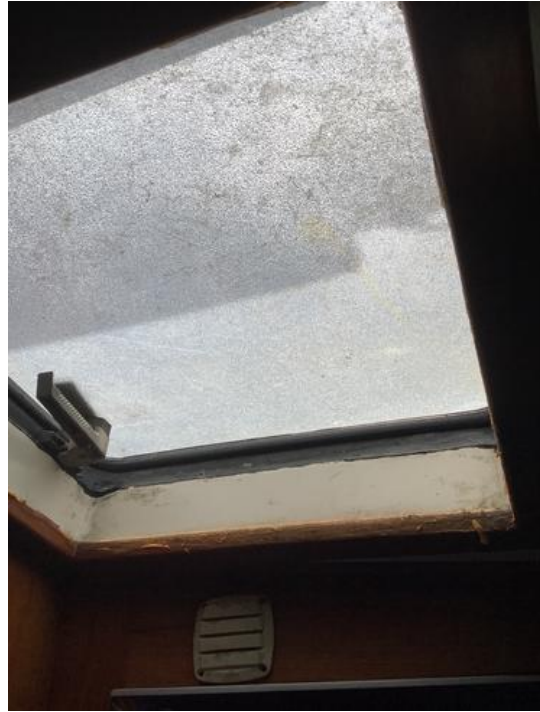
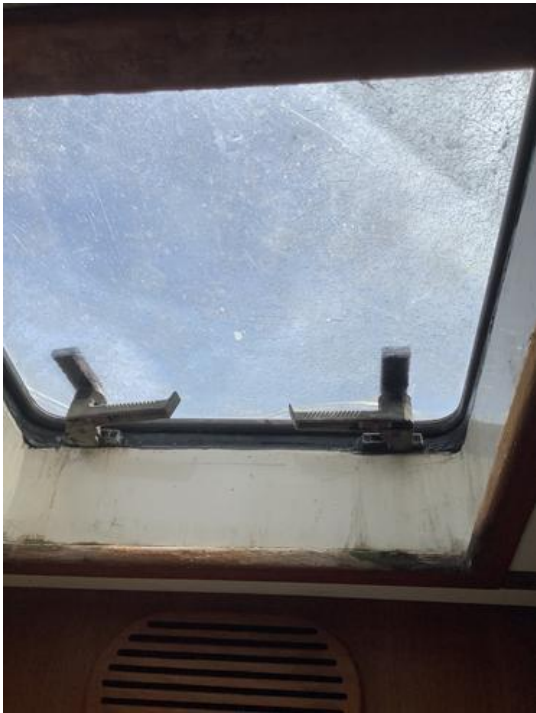
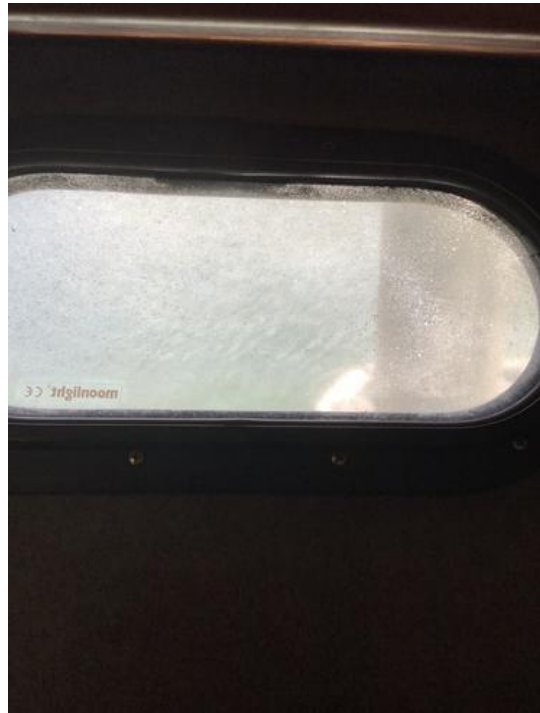
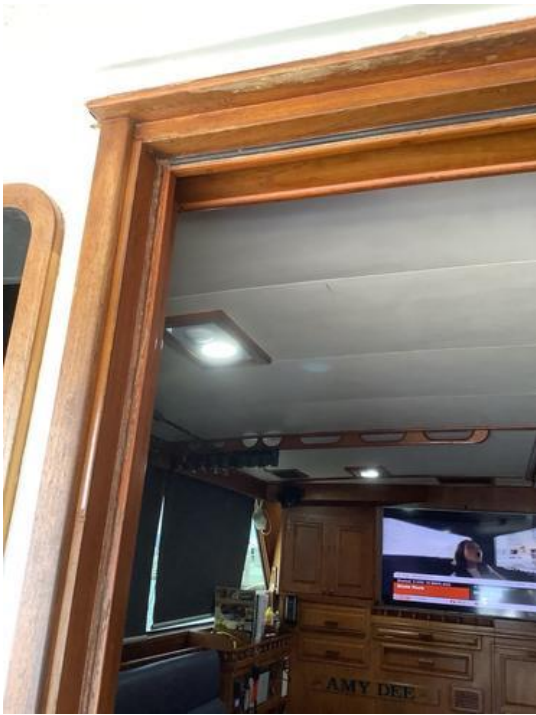
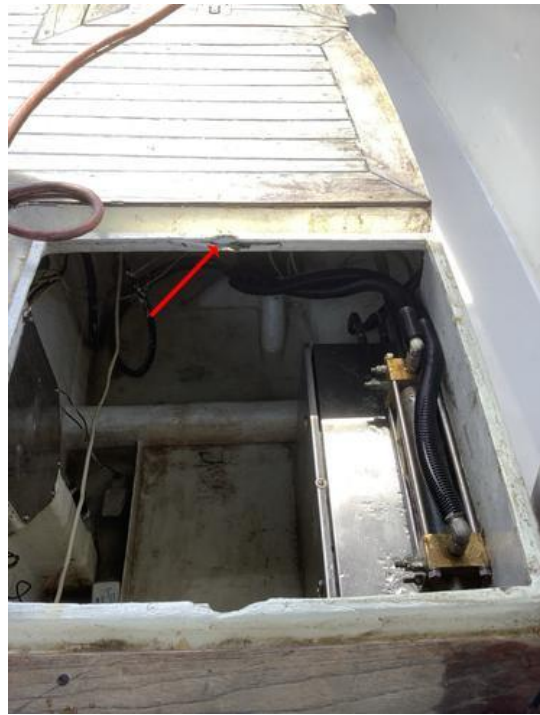
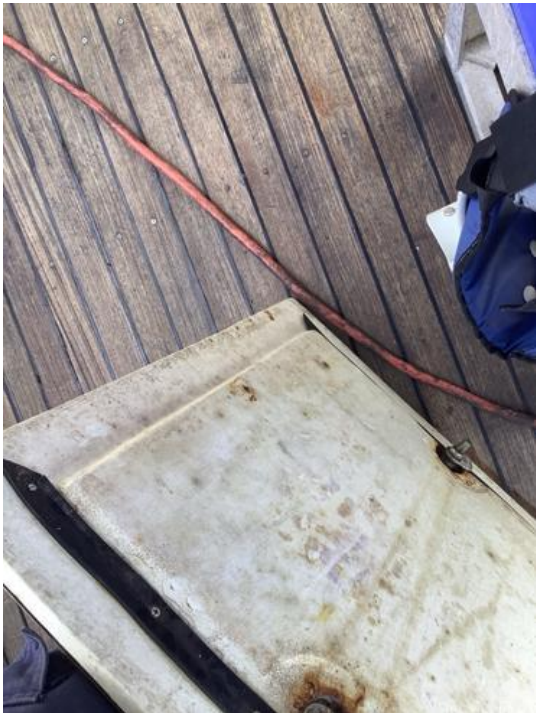
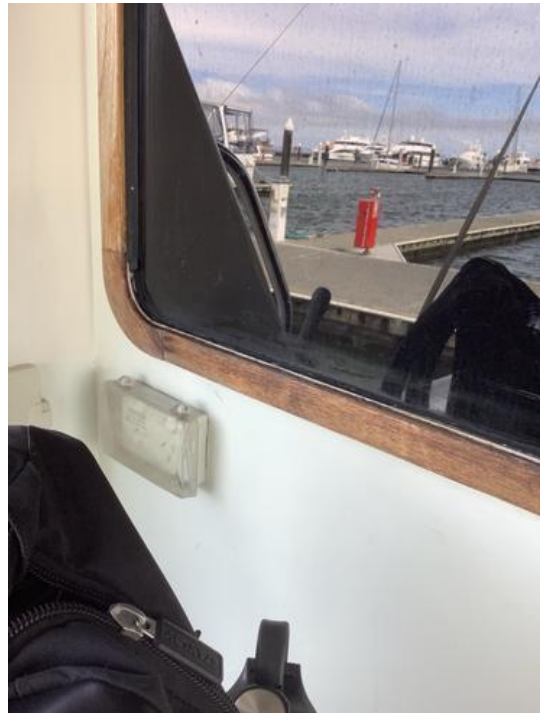
Flush deck hatches fitted to the deck above the galley, main and guest cabin were heavily crazed and required replacement. It is recommended that covers are placed over the hatches before the vessel is operated outside of sheltered waters.

The seal for the main salon door is damaged, this should be repaired

The seal on the steering flat flush deck hatch is not sufficient, one side is missing. Requires repair.  
Rain water leaking through the hatch  
Seals on all flush deck hatches should be repaired.

Perform maintenance on all hatches, doors, and windows to preserve weathertight integrity.

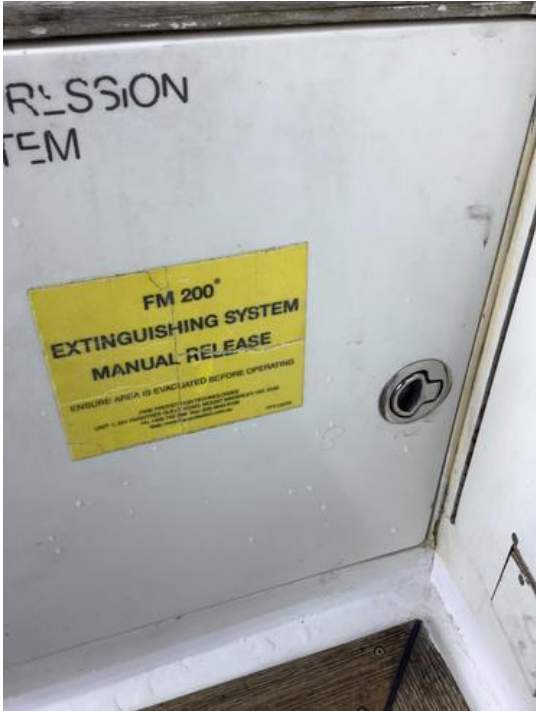
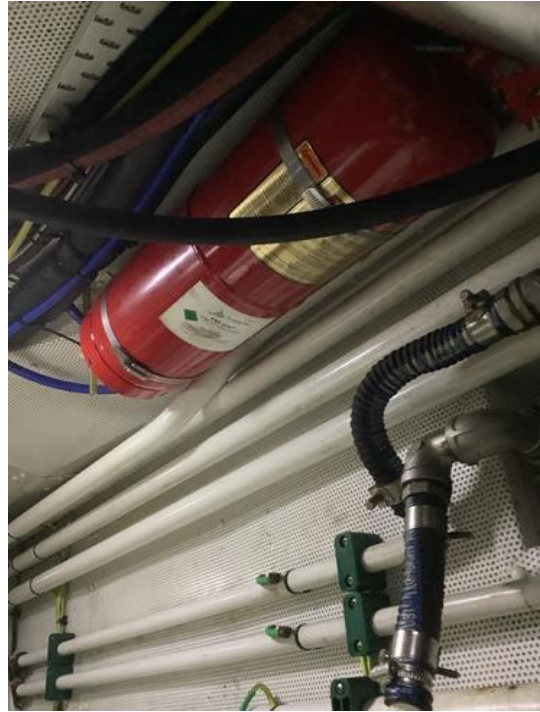
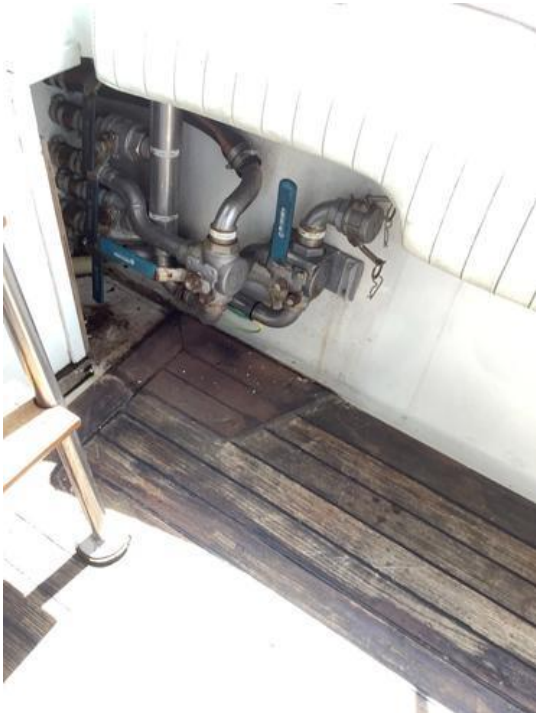
Fm200 fire suppression system fitted to the machinery space, no evidence of the last inspection. Evidence to be supplied that an authorised agent has inspected the system.

Fire hydrant for fire system. No certificate was onboard at the time of the inspection.  
3 x 4.5kg dry powder fire extinguishers fitted. Both extinguishers are due for an inspection.  
Portable fire extinguishers shall be inspected every 6 months.

Service the fire system thoroughly and obtain a safety certificate to confirm its compliance and effectiveness. Replace or service portable fire extinguishers.

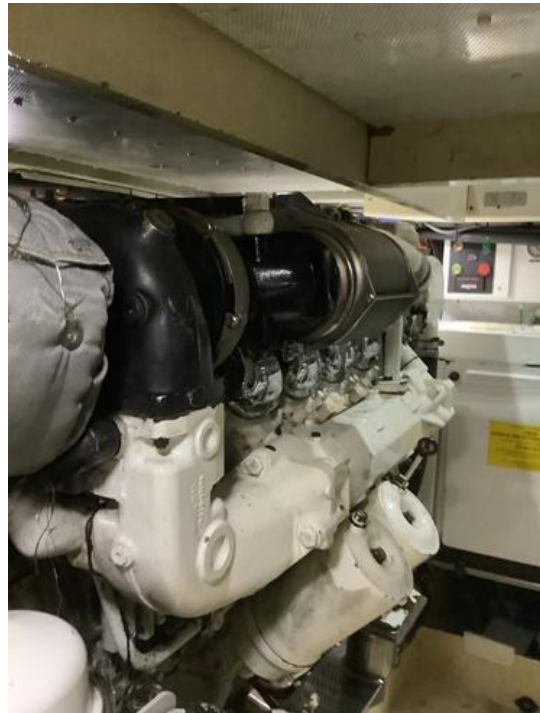
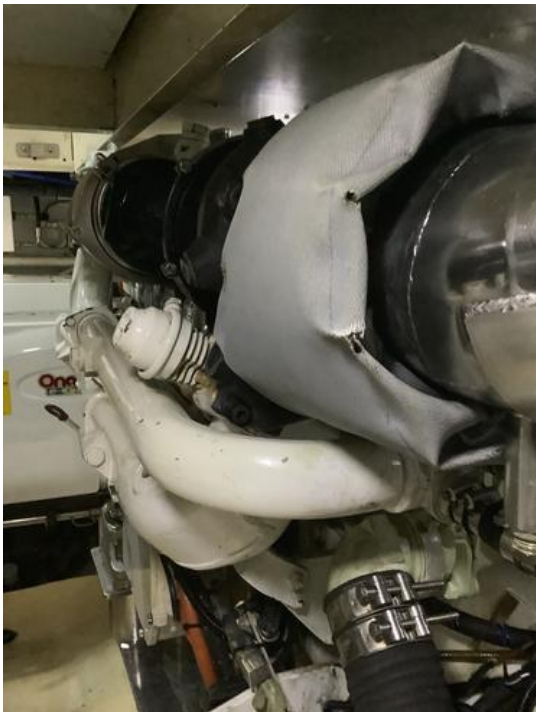
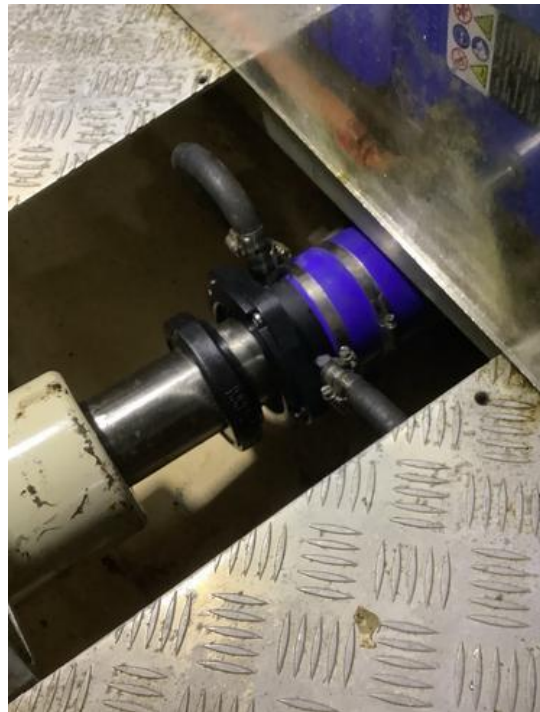
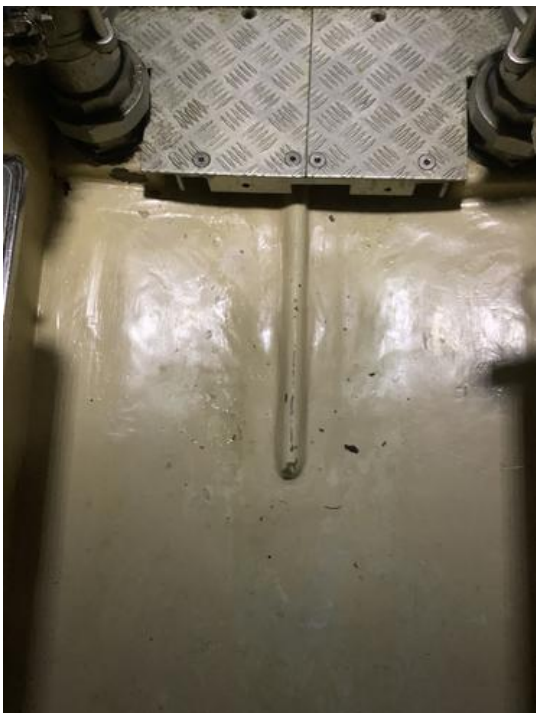
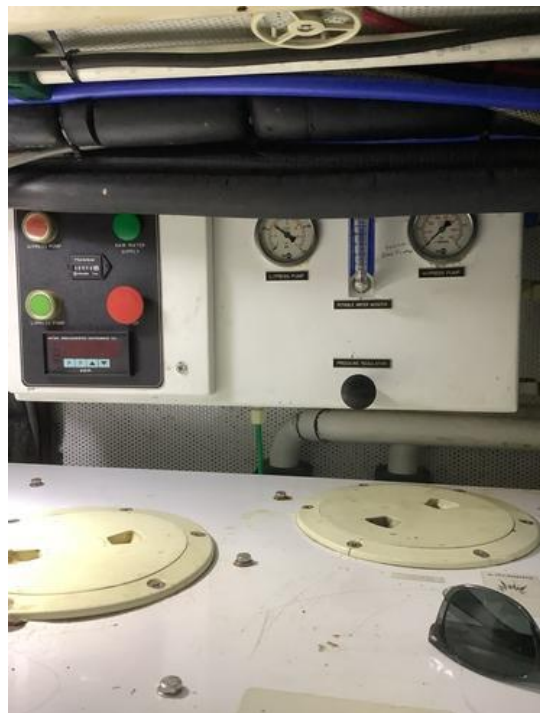
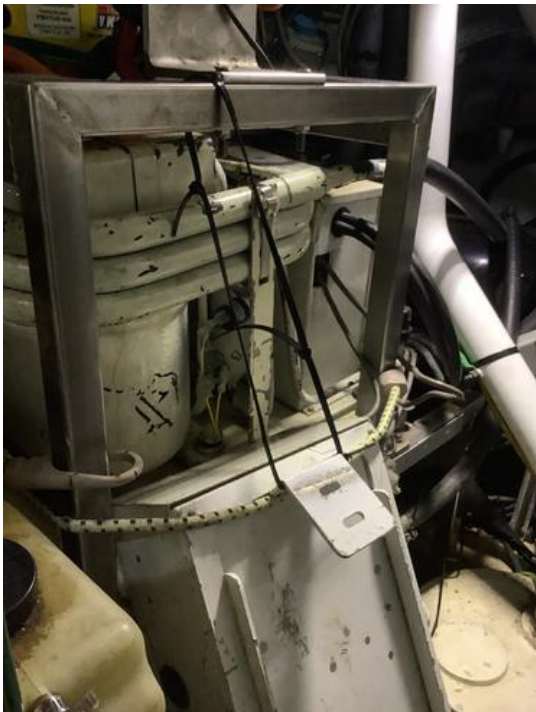
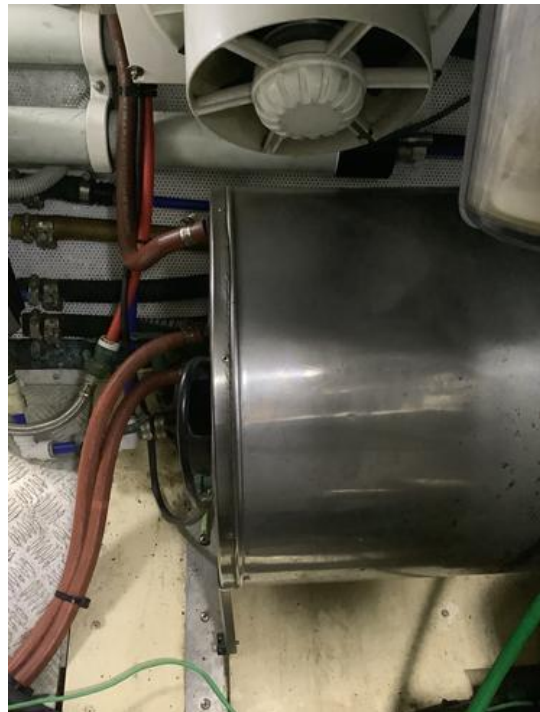
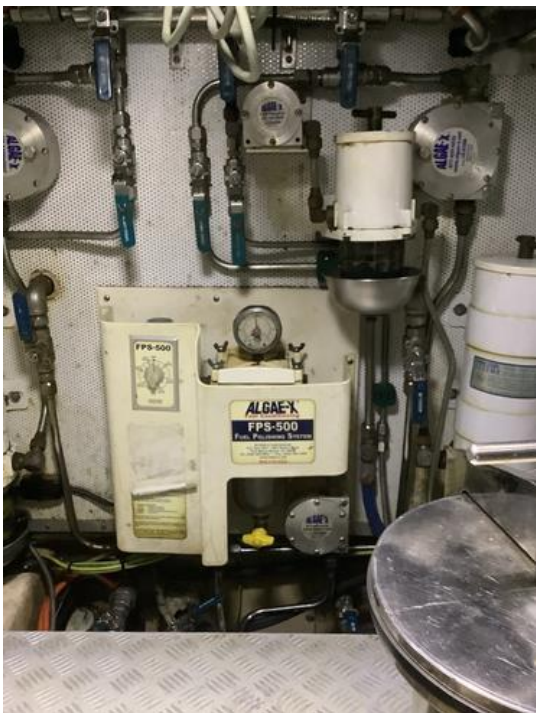
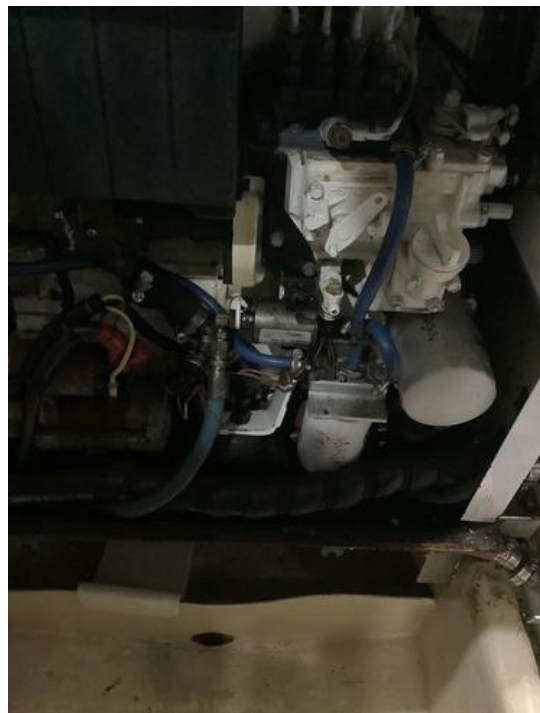
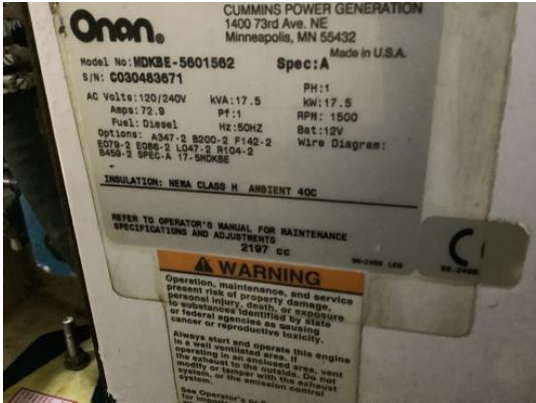
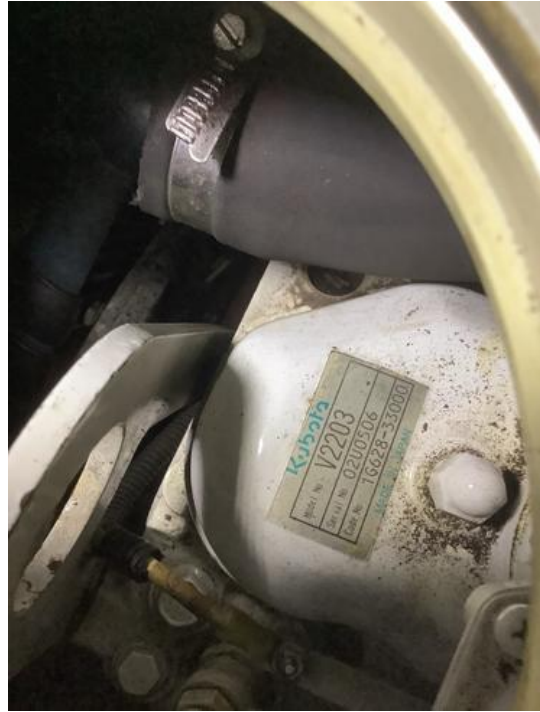
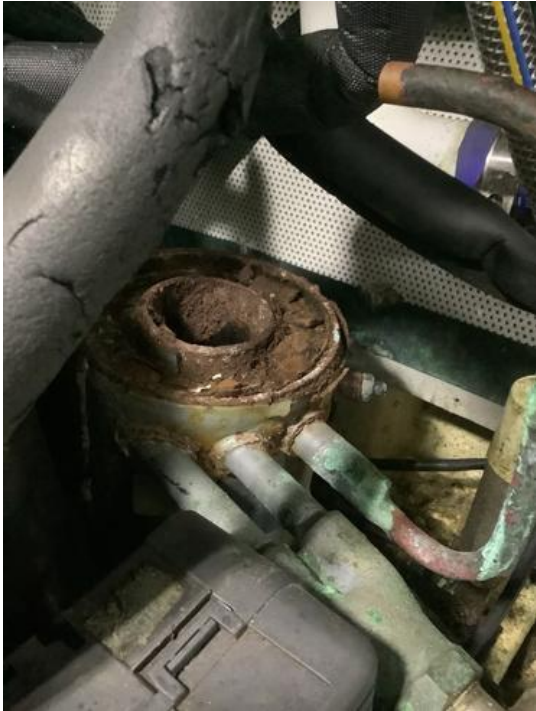
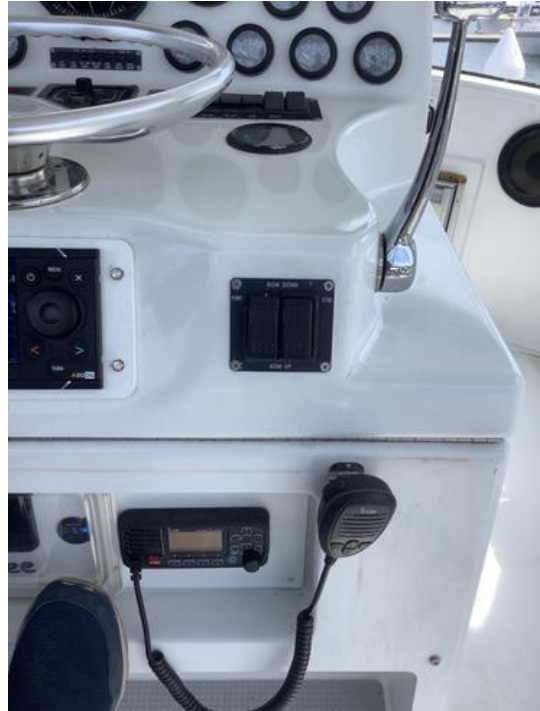
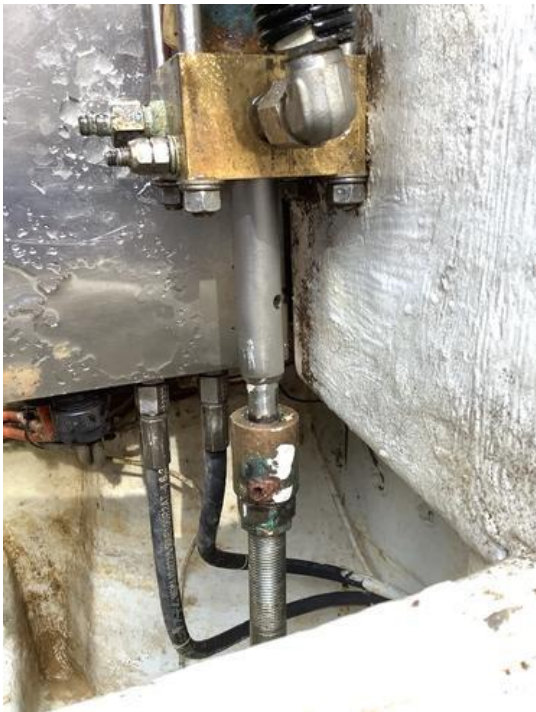
- 2 x V8 800Hp MAN engines - servicing up to date and fitted to the vessel in 2014.
- Gearboxes were Twin Disc EXC250 - Replaced in 2014
- Shaft seals- Tide seals
- Oman generator and Kubota auxiliary engine
- Algae x fuel conditioning system, all fuel lines and hoses were in satisfactory condition
- Watermaker (RO plant unknown manufacturer, was not tested at the time of the survey)
- Hot and FW system
- Hydraulic steering system; the grub screw on the tiller arm is corroded and requires replacement.

No major defects were found with the machinery on board the vessel.

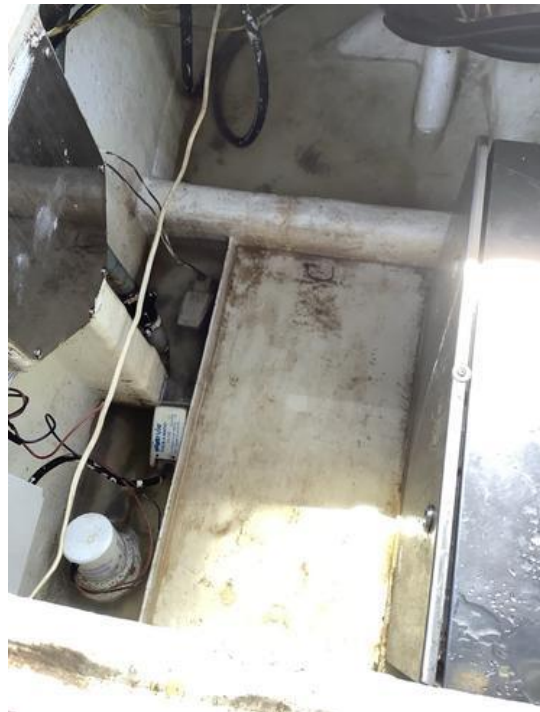
ELV bilge pumps are fitted throughout the vessel.

- 2 x engine room
- 1 x steering compartment
- 1 x galley
- 1 x fwd accommodation bilge

Bilge pumps and alarms were tested in the engine room.  
All bilge pumps were tested and verified operational.

The bilge manifold situated on the stbd aft deck, the manifold was operational and labelled correctly.  
Tested valve operation.  
Did not test the system as there was no bilge pump onboard at the time of the inspection, it's currently being serviced.

Steering flat bilge had approximately 30ltrs, this was pumped out at the time of the inspection.

Install either a manual or powered emergency pump to service the vessel's bilge and fire system

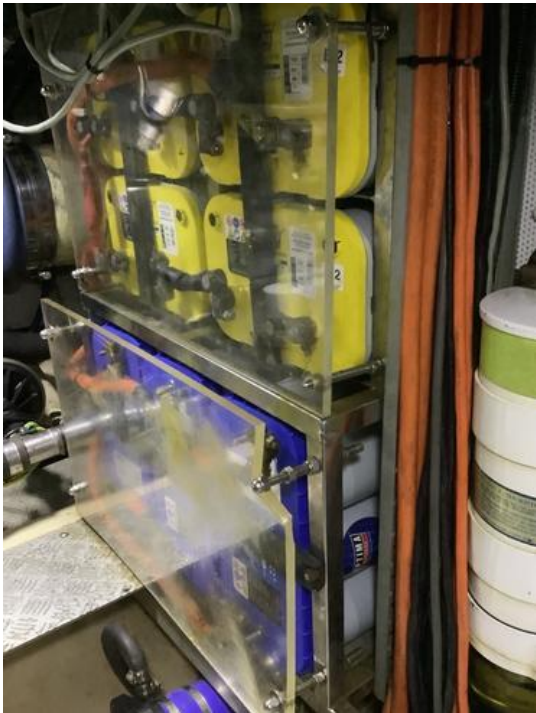
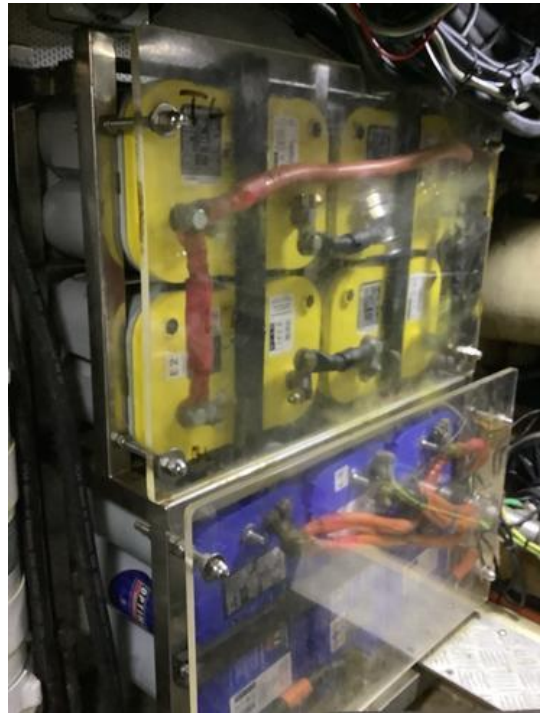
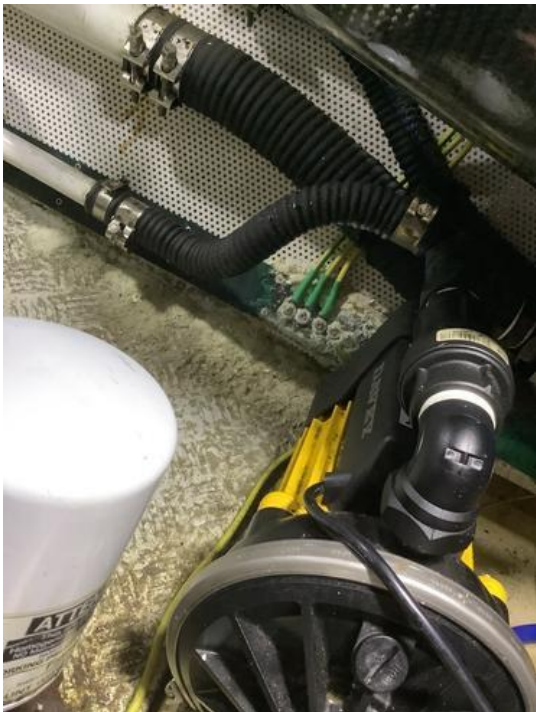
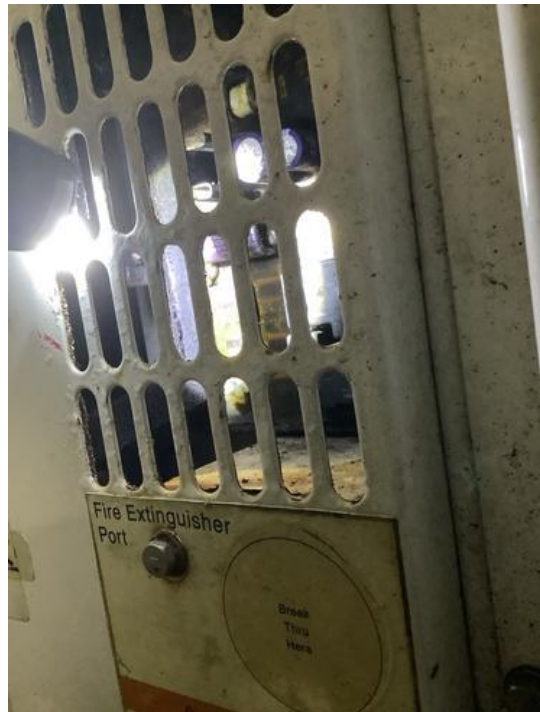
Service and start Batteries were located on the aft bulkhead, no defects were identified. No evidence on board that the vessel has been inspected by a licensed electrician. Recommend the electrical system is inspected by an unrestricted licensed electrician, RCDs should be tested and the vessel issued with a certificate of electrical safety. Insulation testing of all AC motors and generator windings shall be inspected once every 5 years.

Conduct a comprehensive electrical safety inspection, including a 5-yearly examination of Residual Current Devices (RCD) and insulation.

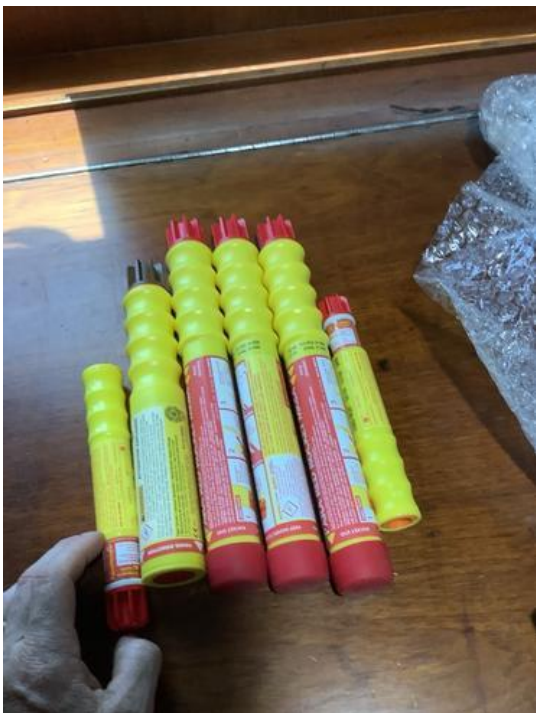
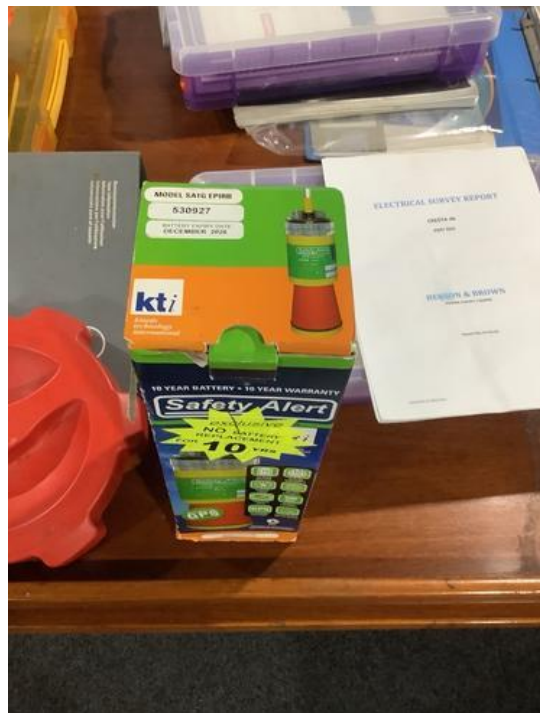
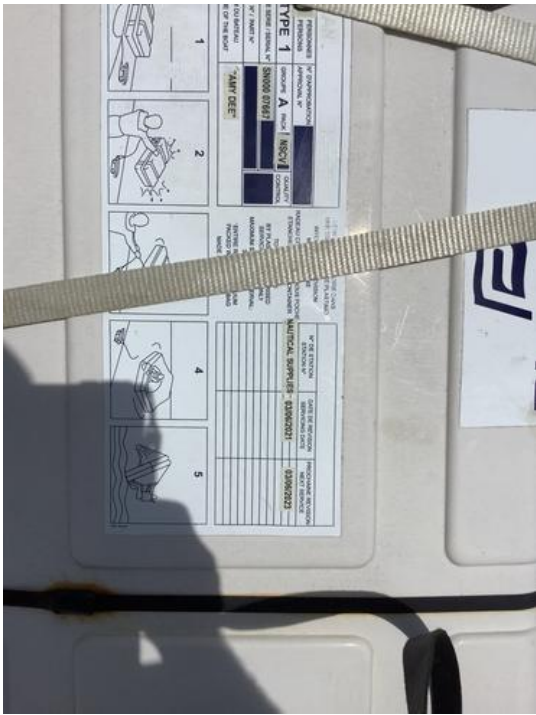
The vessel is fitted with flares, sheets, 3 x first aid kits, 3 x EPIRBs - MoB beacon, grab bag and fitted in the main salon.

No life jackets were onboard at the time of the inspection. 10-person coastal life raft requires servicing.

Ensure the safety and first aid equipment is up-to-date by implementing necessary updates and servicing.
